Manhole Inspection Summary

Manhole # S17CC1007MH

Insp Date: **2/20/07 10:48 AM**

Location Address: **2257 PARK HILL AVE**

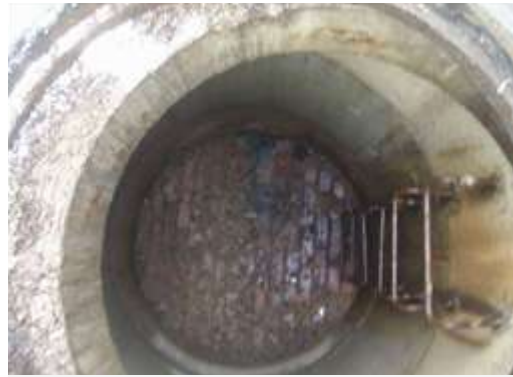
Top View

Frame offset. Channel debris.

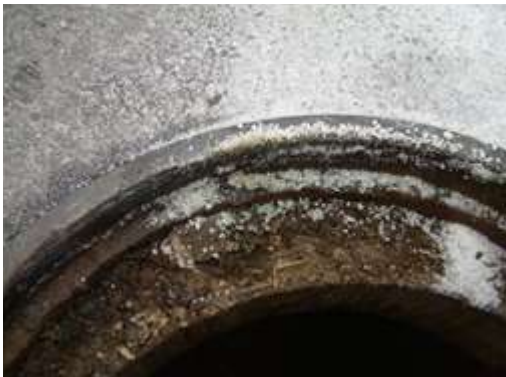
Defect

Frame leaks. Adjustment infiltration.

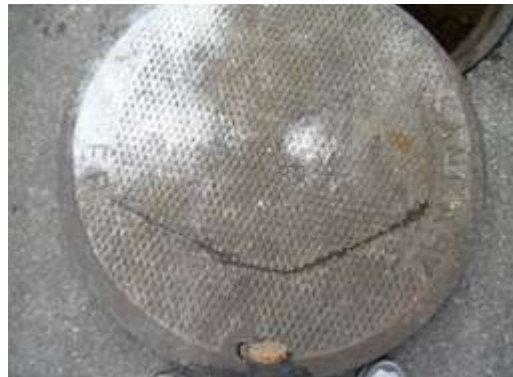
Defect

Cracked lid

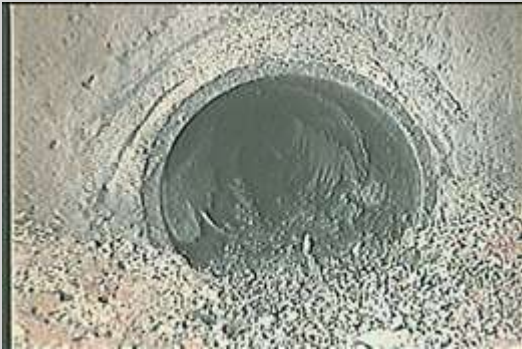
8 in. Circular Gravity Sewer
Pipe Out @ 12 O'Clock

Deposits: ☐ None ☒ **Mud** ☐ Sludge ☒ **Debris** ☐ Grease

Infiltration: **Evidence**
